Manhole Inspection Summary

Manhole # S37AA1034MH

Insp Date: **1/2/07 9:05 AM**

Location Address: **515 35TH ST**

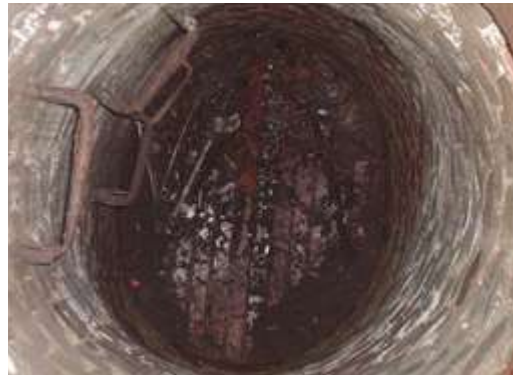
Top View

☒ **Debris** (not Condition related)

Count: **4** Missing: **0** ☒ **Corroded**

Corroded steps. Channel debris.

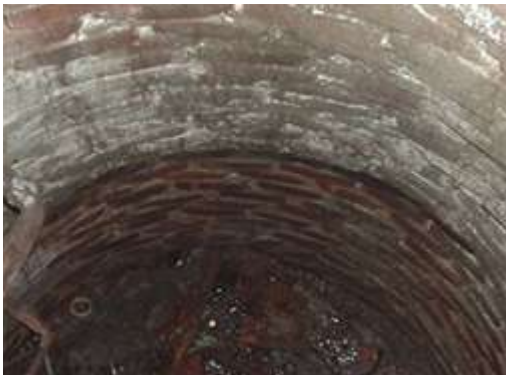
Defect

Infiltration: ☐ None ☐ Joint ☐ Cracks ☐ Mortar ☐ Roots ☒ **Wall**

Barrel infiltration.

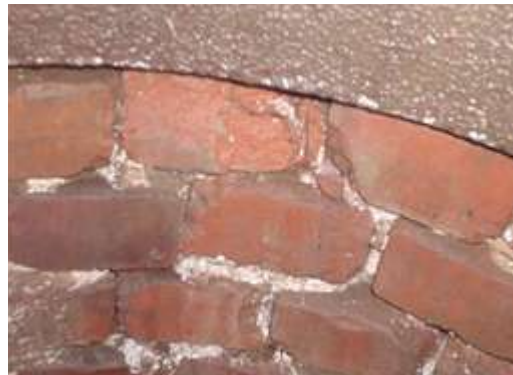
Defect

☒ **Leaks**

Condition: ☐ Sound ☐ Cracked ☐ Root Intrusion ☐ Loose Brick ☒ **Deteriorated**

Infiltration: ☐ None ☒ **Joint** ☐ Cracks ☐ Mortar ☐ Roots ☒ **Wall**

Frame leaks. Adjustment deterioration and infiltration.

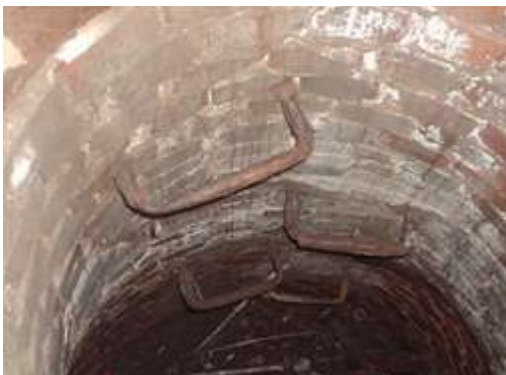
Defect

Adjustment and Barrel infiltration.

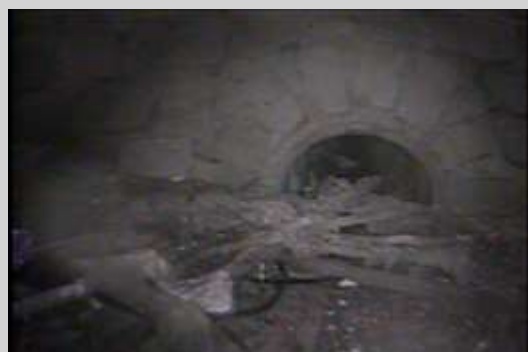
Pipe Out @ 12 O'Clock

Deposits: ☐ None ☒ **Mud** ☐ Sludge ☒ **Debris** ☐ Grease

Silt Depth: **4** (in.)

Pipe Seal Cond: **Cracked**
